**ECOLOGICAL RESTORATION OF PUBLIC LANDS  
IN WEST VIRGINIA: MONONGAHELA NATIONAL FOREST  
AND NEW RIVER GORGE NATIONAL PARK  
2024**

# MONONGAHELA NATIONAL FOREST: THE MOWER TRACT

## NEW RIVER GORGE: WAR RIDGE

## NEW RIVER GORGE: HYLTON STRIP

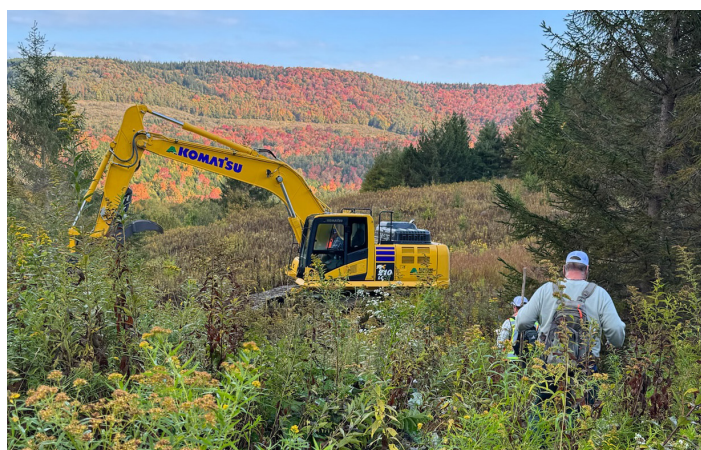
Contractors walk an excavator to the restoration area to begin pond decommissioning in fall of 2023.

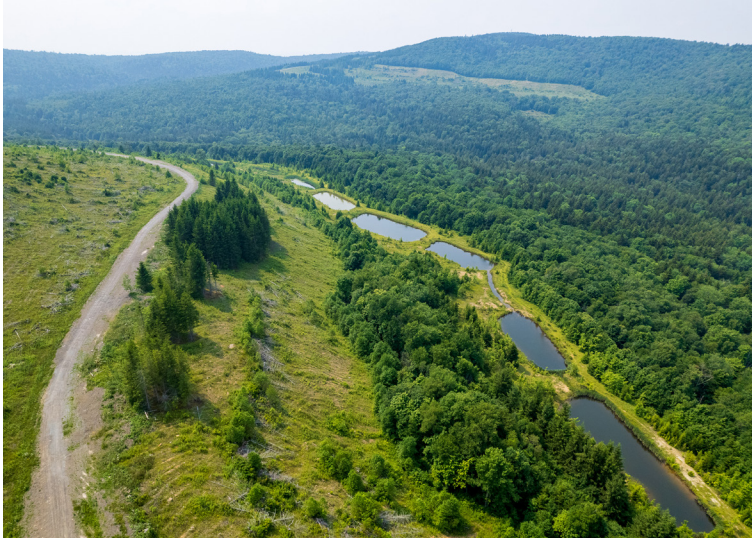
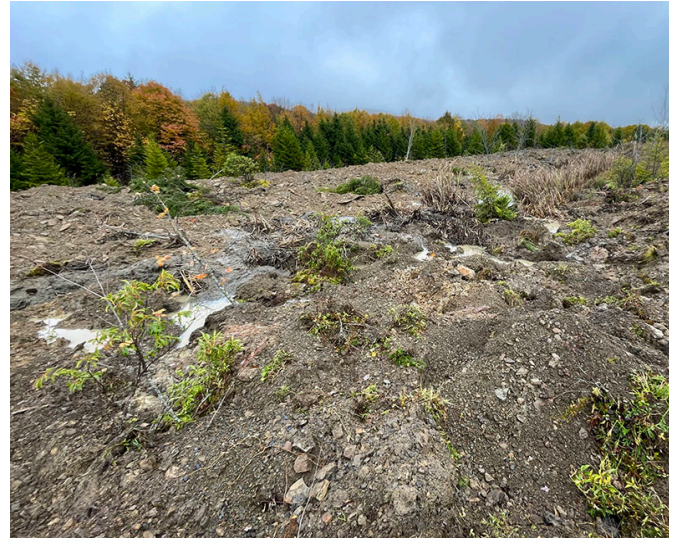
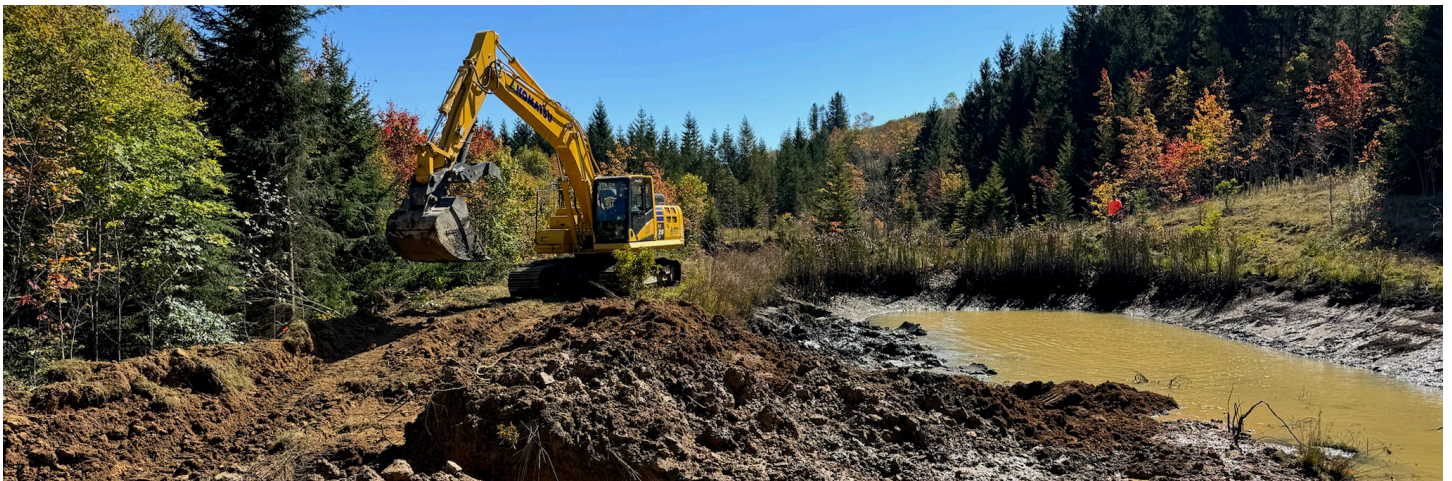
Left: Aerial view of the ponds before work begins on their removal. Right: Post removal landscape in an area where one of the ponds was decommissioned. Bottom: The downgradient berm of the pond is eliminated and pushed into the depression where water once stood.

On the Mower Tract are a series of over one hundred abandoned sediment ponds that border the downgradient side of our restoration area. Under current SMCRA regulations, these would have to be removed as part of the reclamation process. However, these predated SMCRA and were allowed to remain and today serve little ecological benefit. Pre-mining, rain water was slowed by trees and vegetation, filtered into the soil, and slowly made its way underground to streams that reach the Shavers Fork of the Greenbrier River below the Mower Tract. After the mining, water was unable to infiltrate the soil due to heavy compaction by mining equipment, flowed quickly over the surface of the land and collected in the sediment ponds, where it was exposed to air temperatures and

In an effort to address this problem, we initiated a project in 2023 to decommission the ponds and turn them into complexes of small wetlands with greatly reduced ponded area that can be planted with a mixture of wetland trees and shrubs that will grow and eventually shade the area. An area of approximately 60 acres will be converted to wetland complexes on the Mower Tract. Extensive earth moving and restructuring is required, so the project is being implemented in phases. Phase 1 eliminated 18 ponds on an area covering 23 acres and was planted in spring 2024.

In the fall of 2023, an excavator moved earth, decompacted edges of ponds, built porous “weep berms” that water can slowly release from, and extended soil area for planting with wetland shrubs and trees. In 2024, GFW and partners planted 100,754 trees and wetland shrubs of 18 native species on 28 acres of decommissioned mine ponds enhanced to wetland complexes as well as 36 acres of supplemental plantings in previous years’ restoration areas. Before the planting, 100 lbs of native wildflower, legume, and grass seed was spread over the 23 acres of wetland complexes. Seed species included: rice cut grass, rattlesnake grass, fowl managrass, beggar tick, deertongue, partridge pea, blue vervain, brown eyed Susan, boneset, arrowleaf tearthumb, great blue lobelia, mud plantain, big bluestem, and Indian grass.

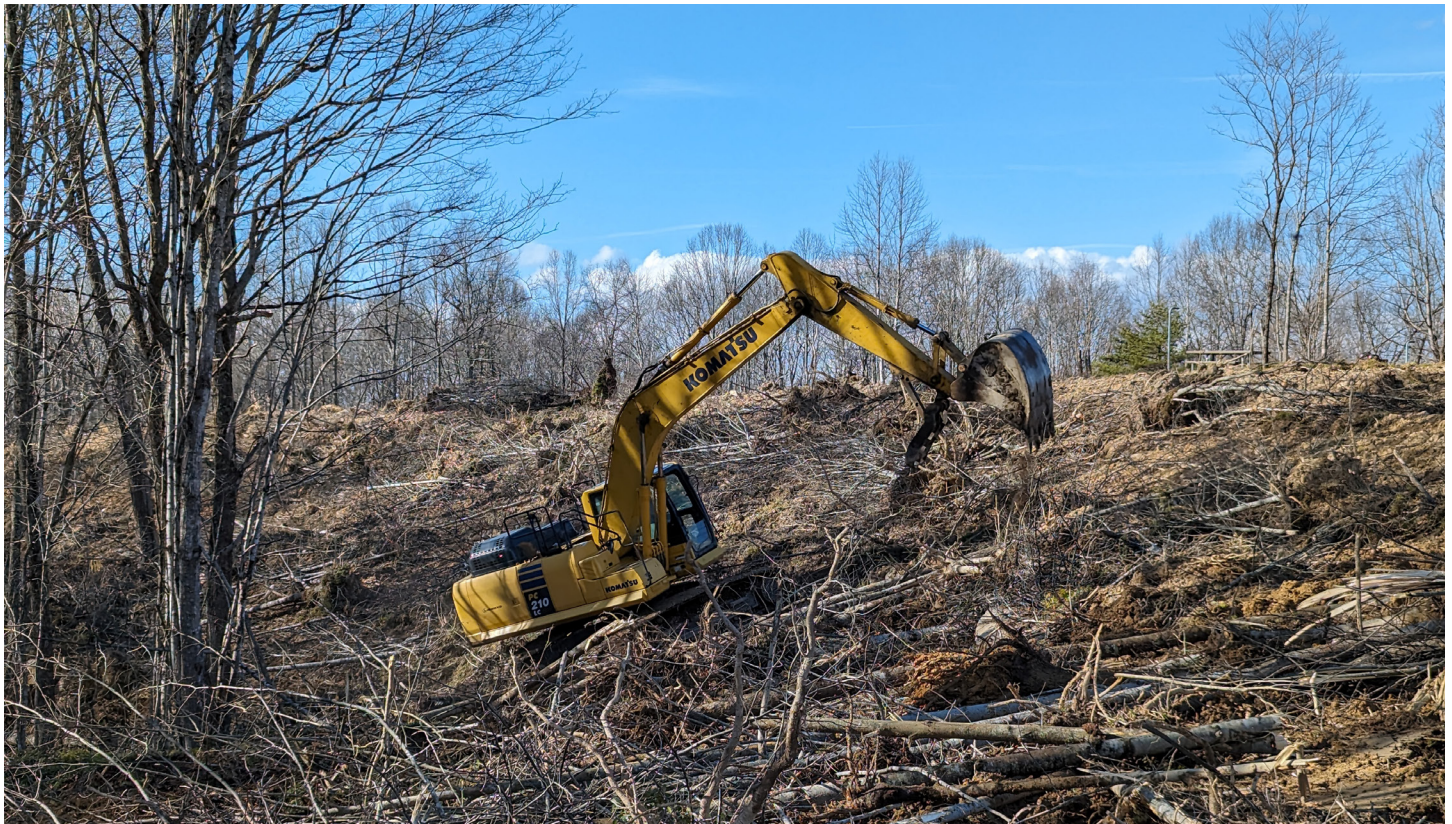
A Komatsu PC 210 excavator scatters woody debris across the decompacted mine spoil. The woody material provides wildlife habitat, protects planted seedlings from deer browse, and provides environmental benefits such as the prevention of soil erosion, retention of soil moisture and soil organic matter input.

On portions of the site that had large accumulations of woody debris, the contractors used an excavator to scatter the woody debris more evenly across the site. On the haul roads, the excavator was used to break down berms along the sides. Smaller trees were felled and scattered during this process. As the woody debris and logs decompose, they will provide valuable functions on the site. The dead wood provides a suitable growth medium for mosses, lichens, and fungi, which support a variety of wildlife. The woody debris also provides habitat for a variety of insects, birds, and mammals. As the wood decays, nutrients and organic matter are provided to the soil, increasing the soil's

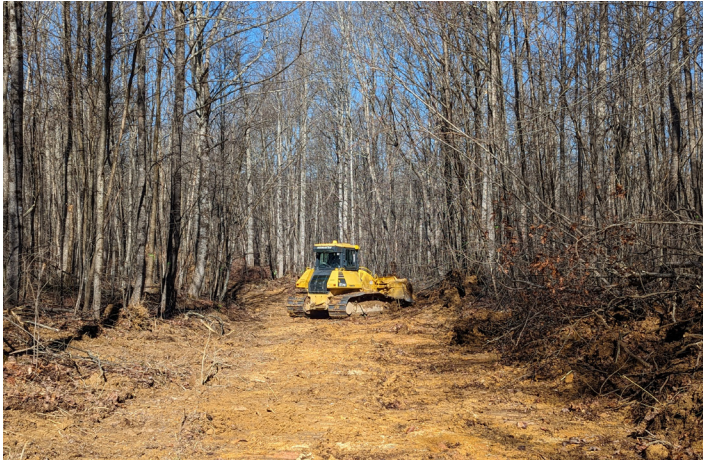
A small bulldozer fells unwanted trees on the haul road.

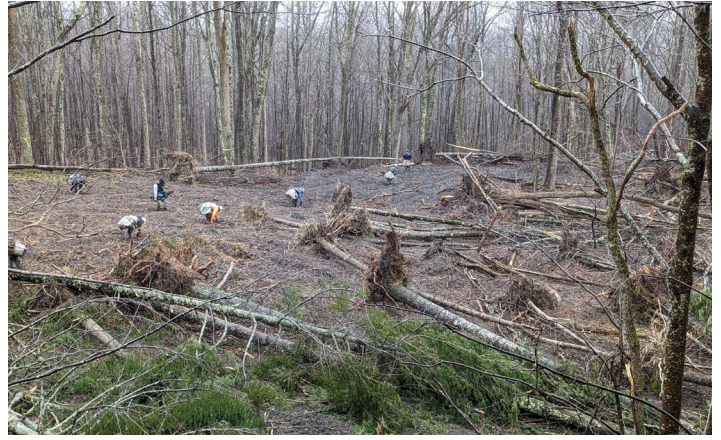
Tree planters reforest a surface mine area which had been decompacted and partially covered with woody debris.

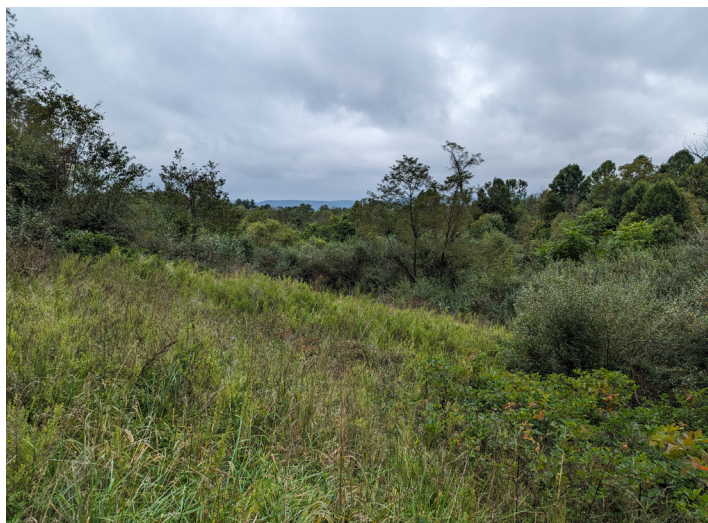
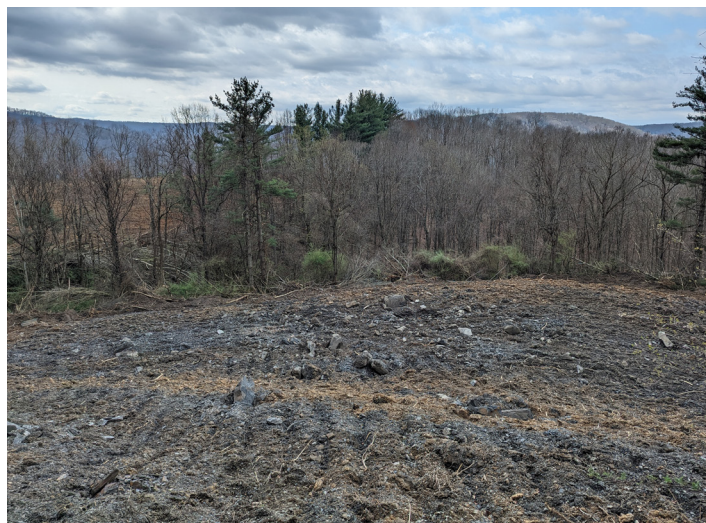
Before (left) and after (right) site preparation at the Hylton Strip restoration area in the NRG.

Restoration activities moved to Hylton Strip after the dozers completed their work at War Ridge. The contractors used small bulldozers to remove the thick groundcovers and unwanted woody vegetation by pushing it into piles and “weep berms” within the reforestation areas and at the project perimeters. The objective was to remove the unwanted vegetation, as well as the top few inches of soil that contains the seedbank, which is composed primarily of seeds of non-native, undesirable species. The berms serve as habitat for insects, birds, amphibians, reptiles, and mammals as they settle and the vegetation decomposes. The material was also used to fill the ditches on the downslope border, and more was piled on top. These berms, as well as the others throughout the site, help prevent or slow surface runoff of water from the areas and prevent offsite erosion and sedimentation of downstream watersheds.

After the vegetation removal was completed, a large bulldozer cross-ripped the site. Unlike War Ridge, the woody debris contained too many invasive species to be scattered. While scattering available woody debris can be helpful for a site, it can be more helpful

scattered the woody debris and felled trees across the road after using the excavator bucket to scoop and dump soil from, or “fluff”, the compacted areas in which the bulldozer could not maneuver or reach. Vegetation removal and cross-ripping was conducted on a total of 107 acres.
